UPPAbaby MESA.

QUESTION: What do I do if there is a gap between the top of my base and my vehicle seat back or a wedge where my vehicle seat back and cushion meet?

WHAT IS A WATERFALL?

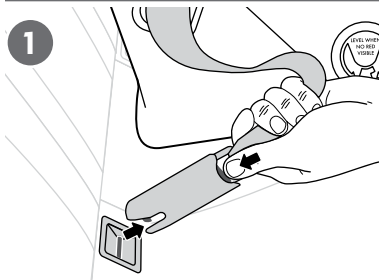
LATCH REMOVAL

- 1 Uninstall your MESA base by pushing the red buttons on the mini connectors (if using LATCH) or by unbuckling the vehicle belt and opening the lock-off door located on the top of the base. Resituate the base back towards the vehicle seat back.

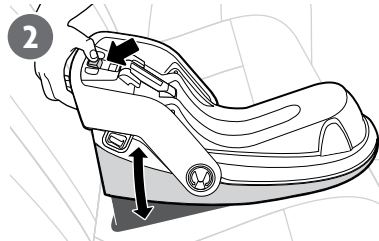
- 2 Adjust the recline foot to achieve proper recline level.

NOTE: Your recline indicator dial is located on either side of the MESA base. It MUST be all green. To adjust the foot and recline angle, push the grey button between the two orange buttons on top of the base and lift upward to extend the recline foot.

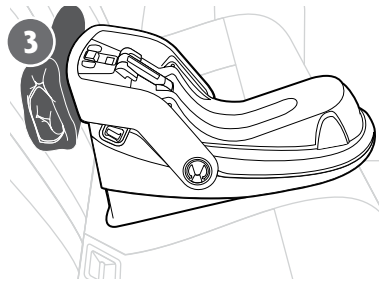
- 3 Push the base into the seat back. If there is a gap present between the top of the MESA base and the back of the vehicle seat, please do the following:

- A Grab a hand towel from your bathroom.
- B Fold it vertically and roll it lengthwise.
- C Place towel in gap flush with the top of the base.
